# Claisebrook Cove

## IDEAS PLAN

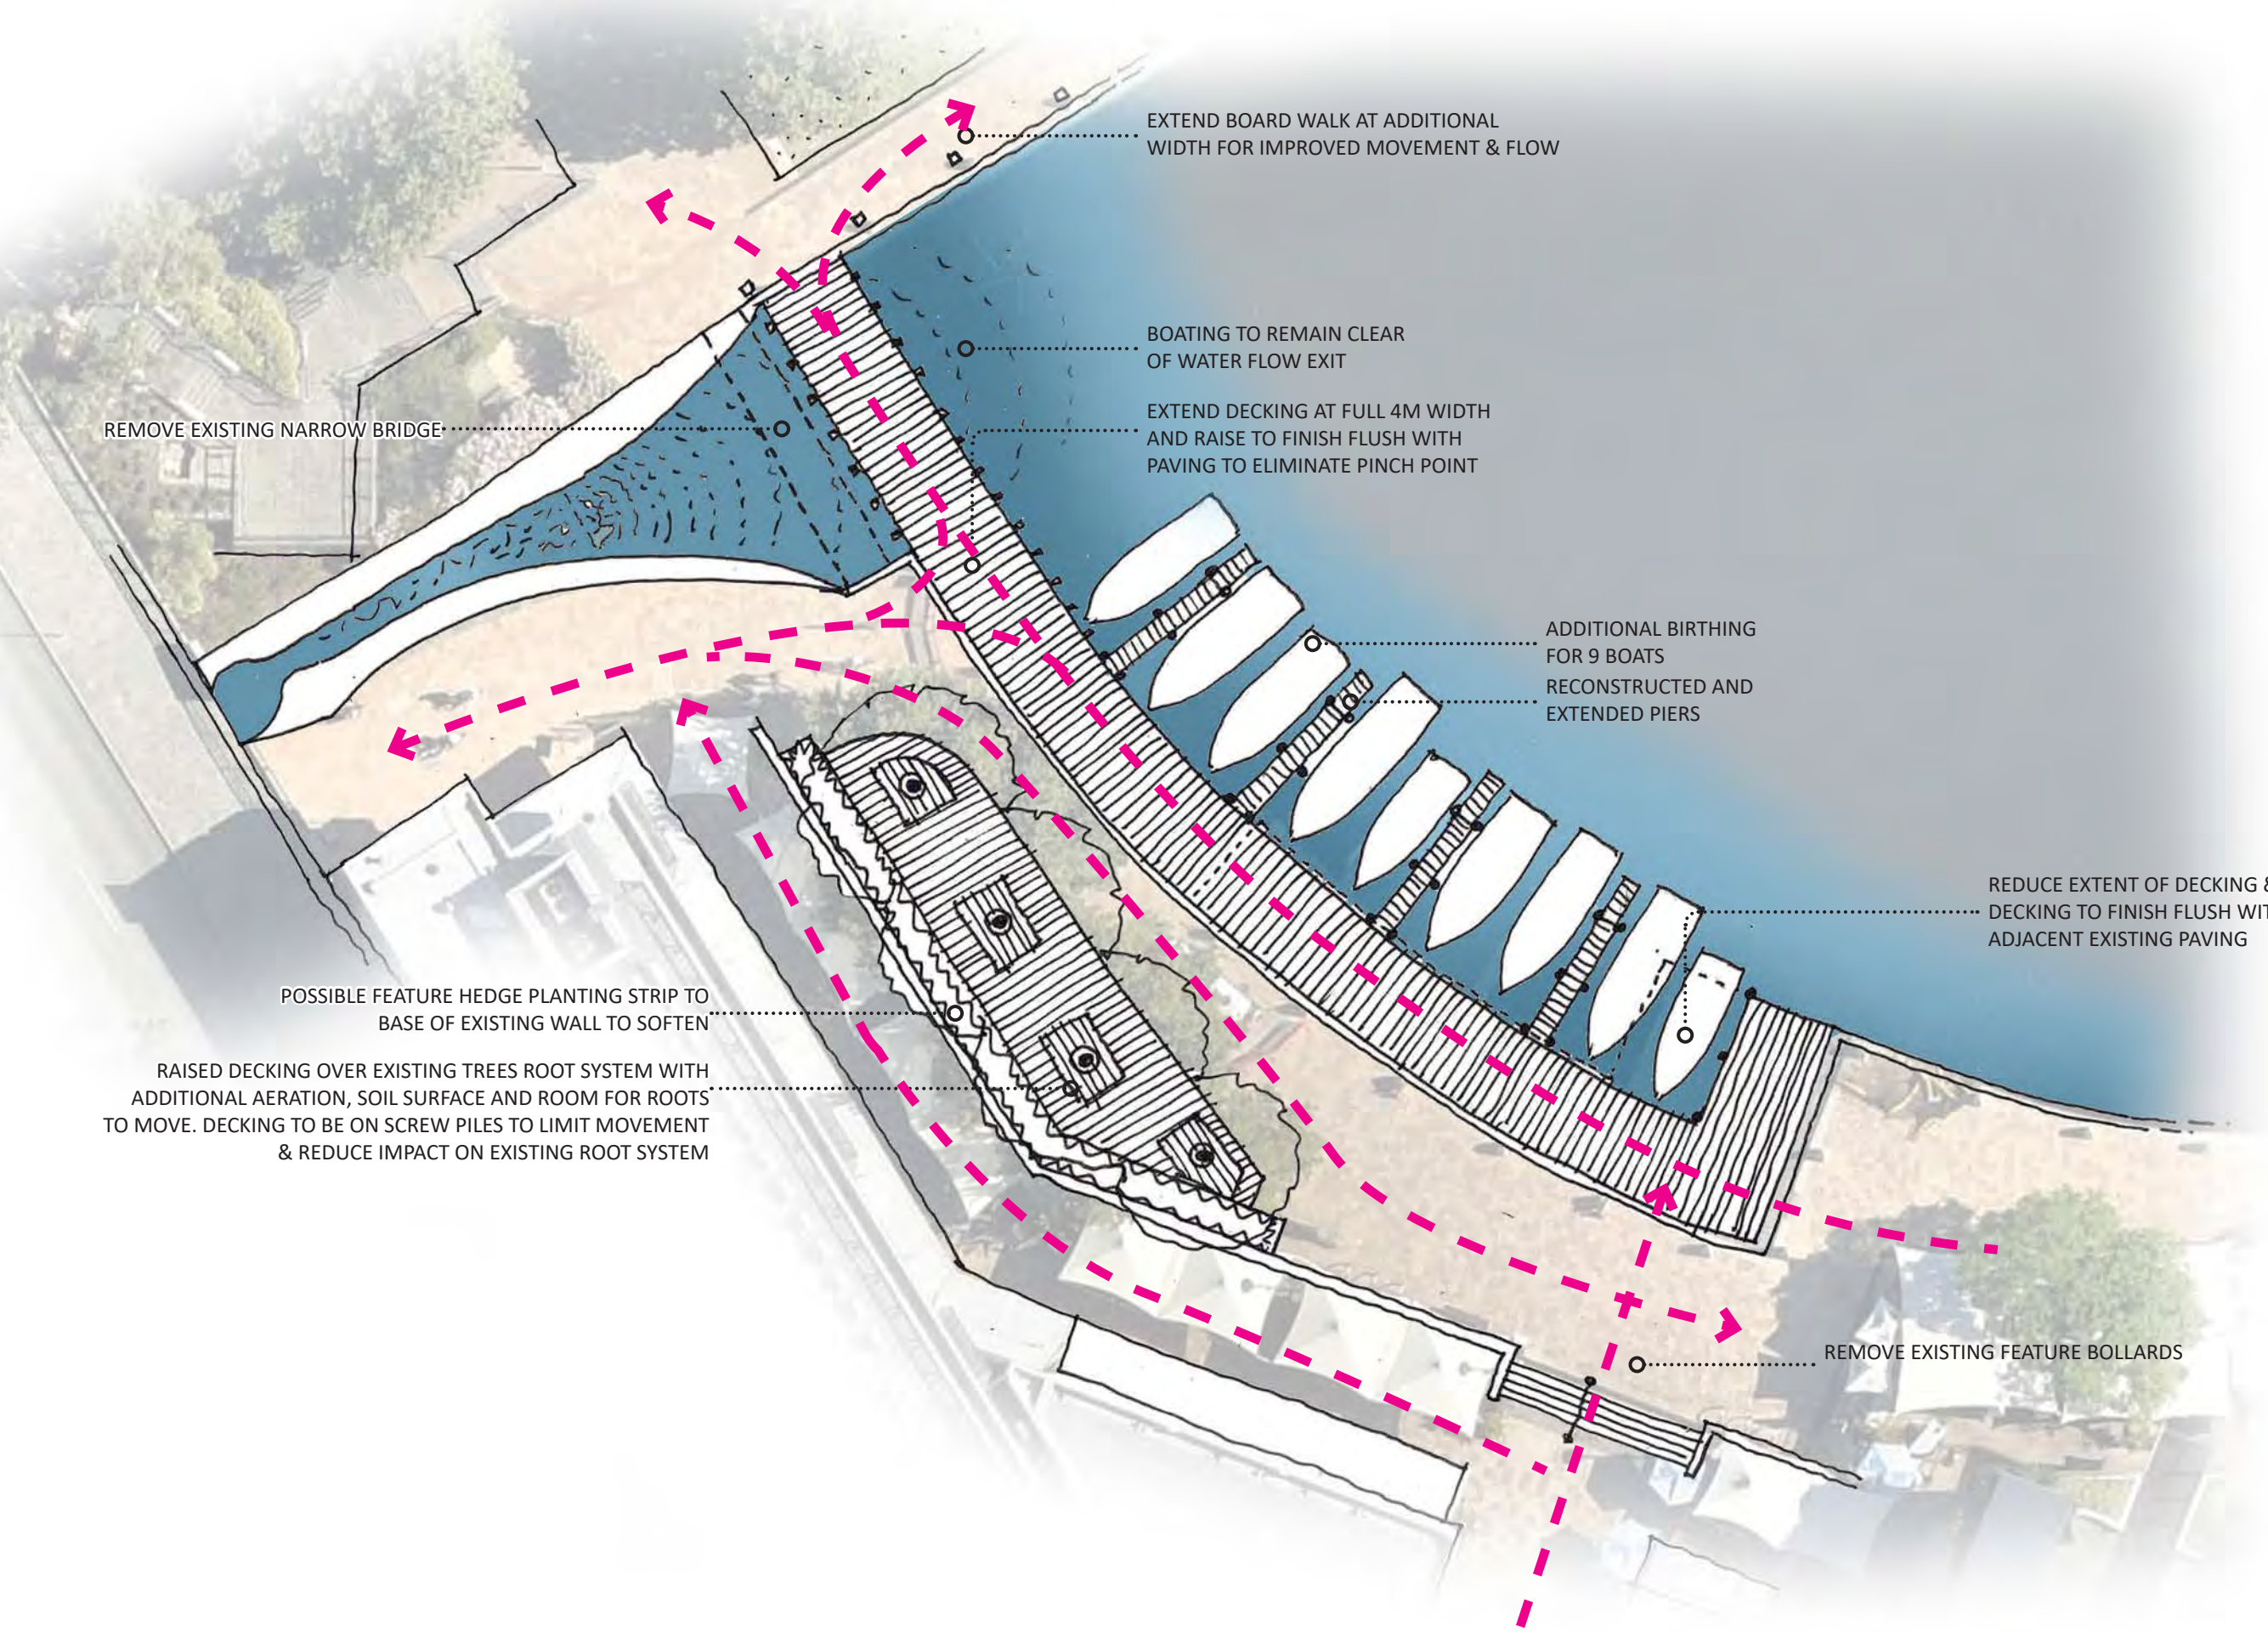
Cracked paving & awkward transitions/interfaces throughout the public realm

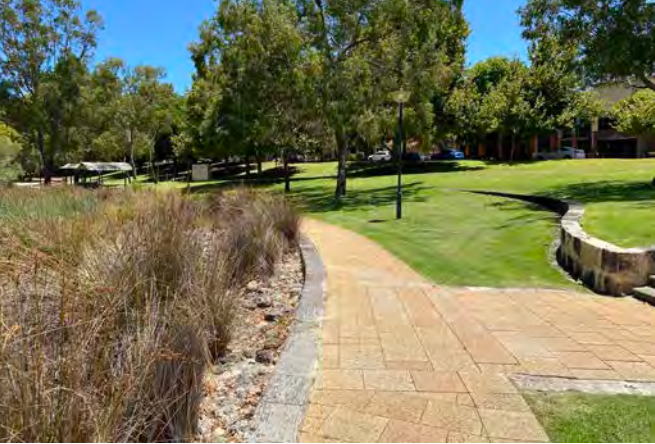
Lack of interaction with the lake. Opportunity to provide educational signage

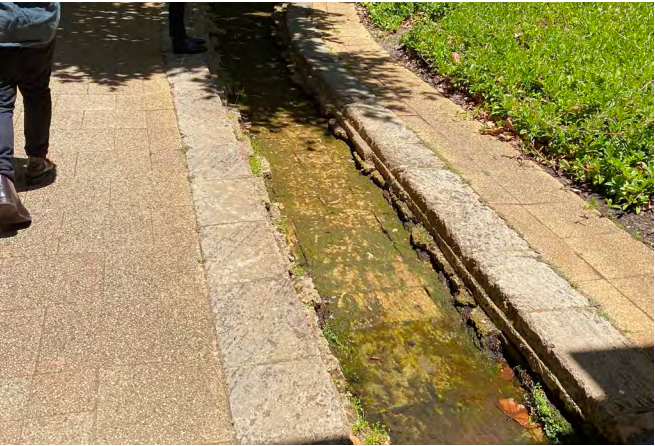
Condition of Existing water way Walls deteriorating

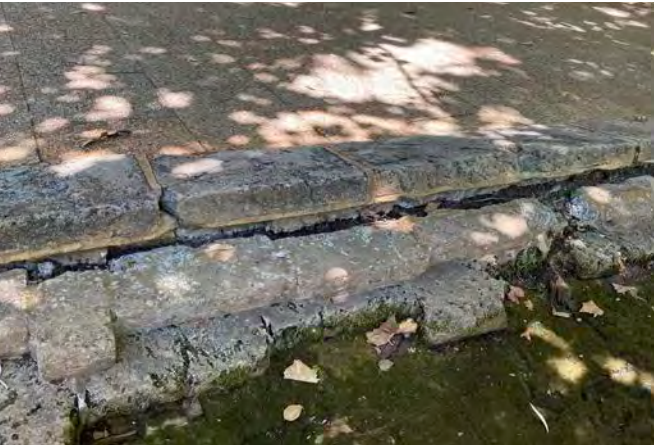
Condition of Existing Walls deteriorating

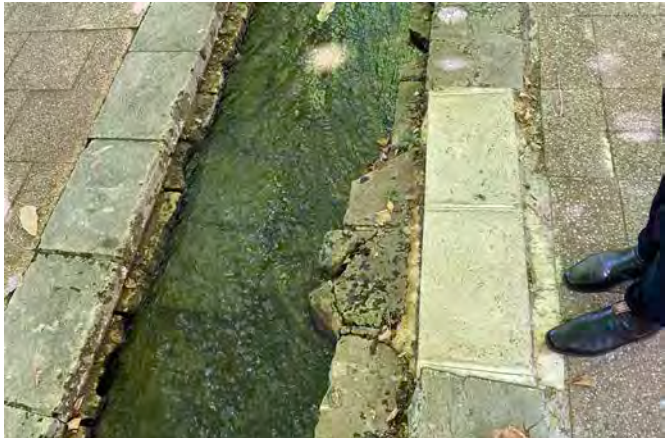
Condition of Existing Walls deteriorating impacting aesthetic & quality of public realm

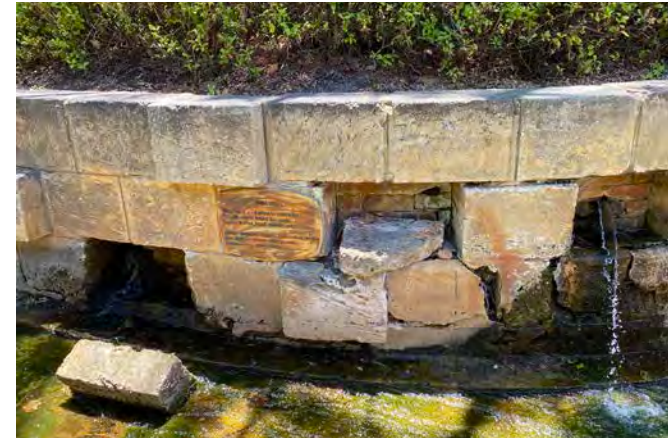
Condition of Existing Walls & water features deteriorating

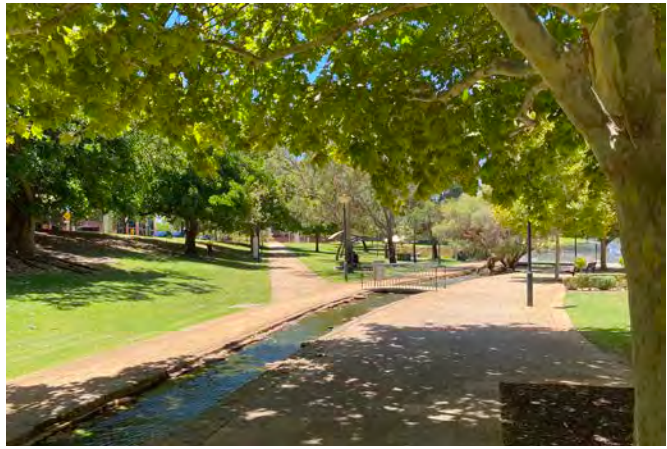
Dated infrastructure & detailing with opportunity to modernise

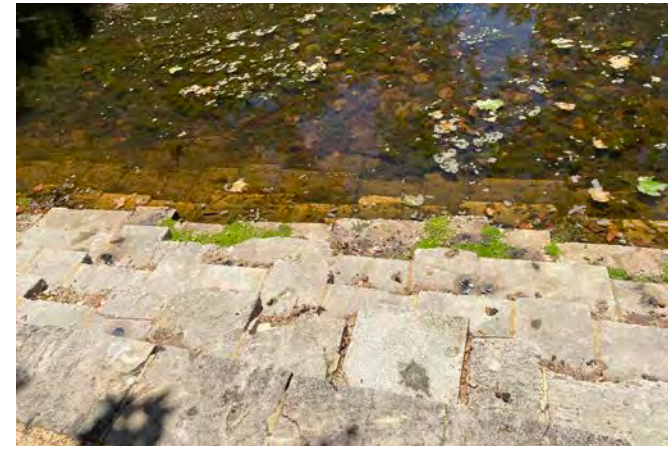
Condition of Existing Walls deteriorating impacting aesthetic & quality of public realm

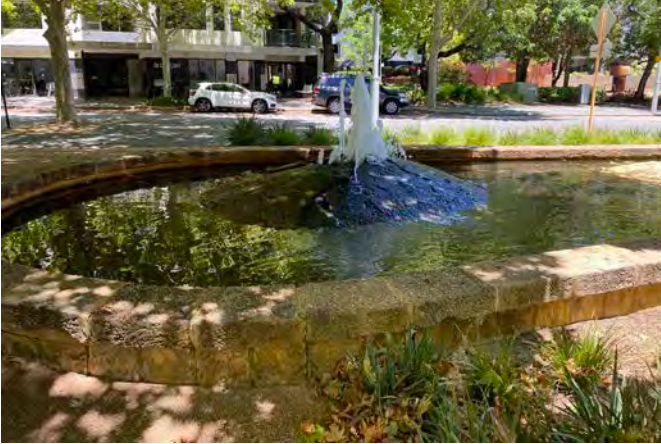
Ageing & degraded walls to water feature

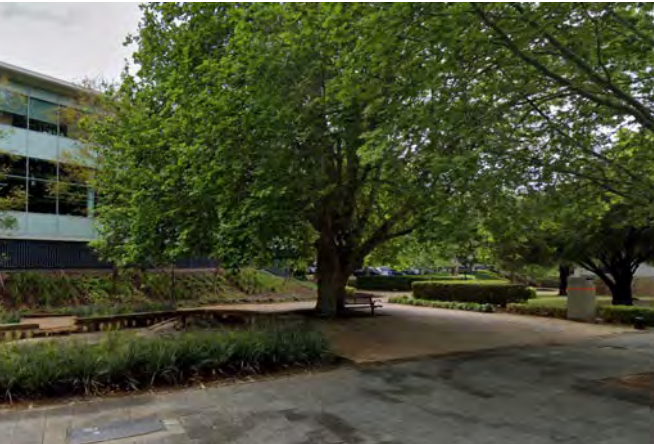
Opportunity to provide greater pedestrian interaction with water feature

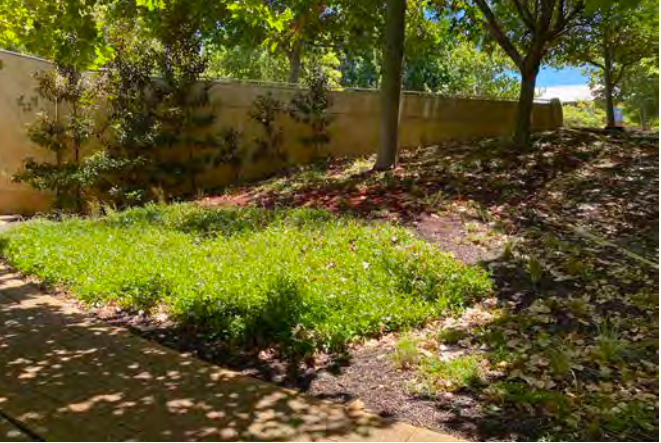
Underutilised landscape spaces throughout project

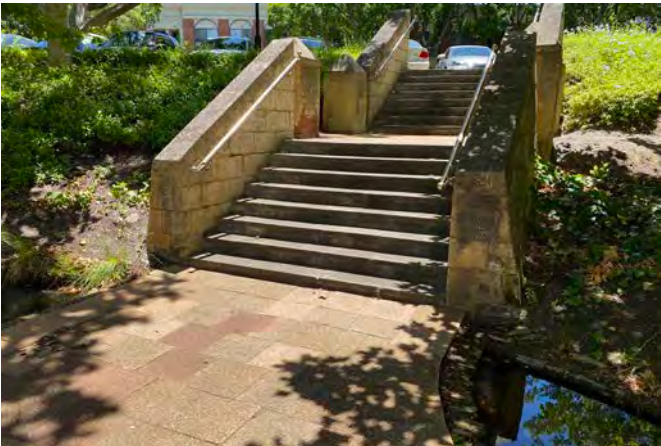
Ageing & degraded infrastructure

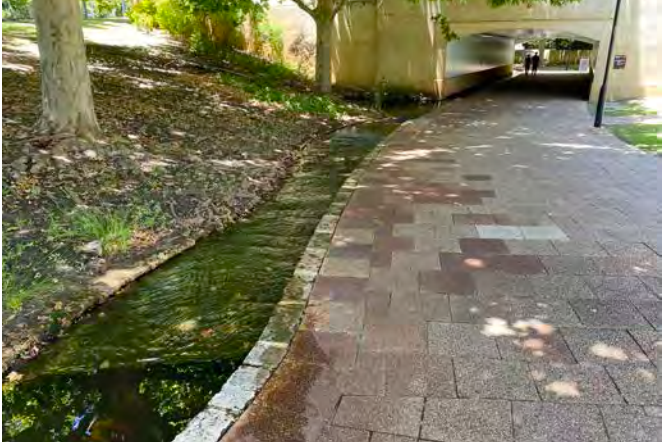
Change of materials & design style. Shade from trees has also impacted understorey

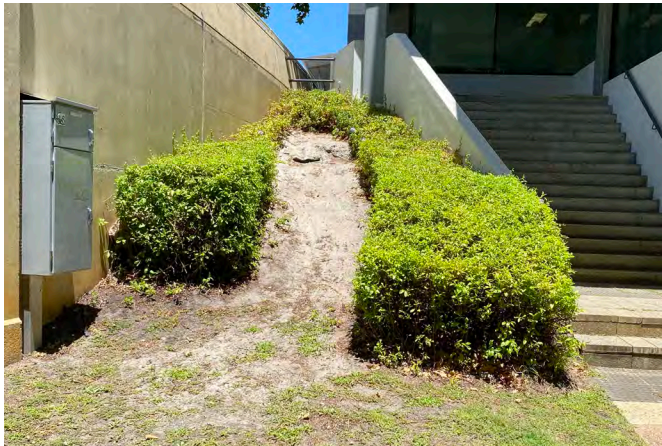
Degraded landscaping to batters. Replace with more suitable landscape response

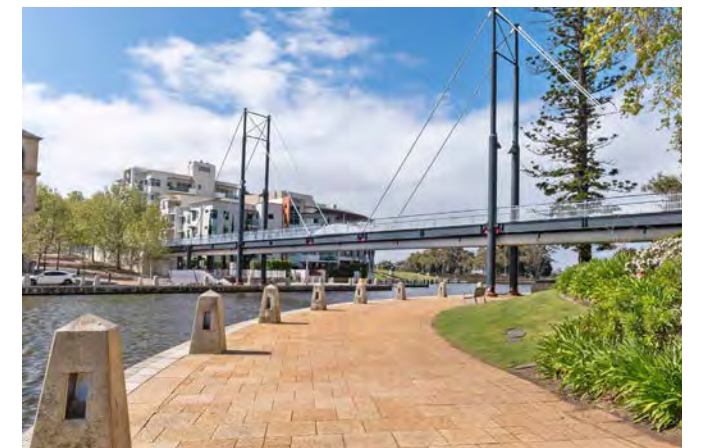
Consideration required to path width & safety along cove edge
