# Claisebrook Cove

## IDEAS PLAN

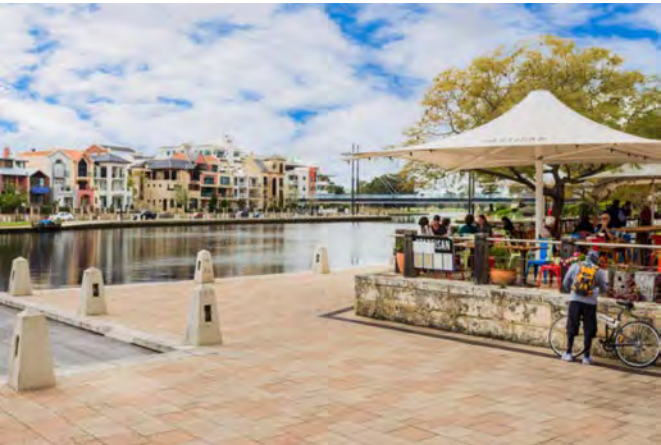
Current configuration of jetty provides an awkward experience for people moving through the site.

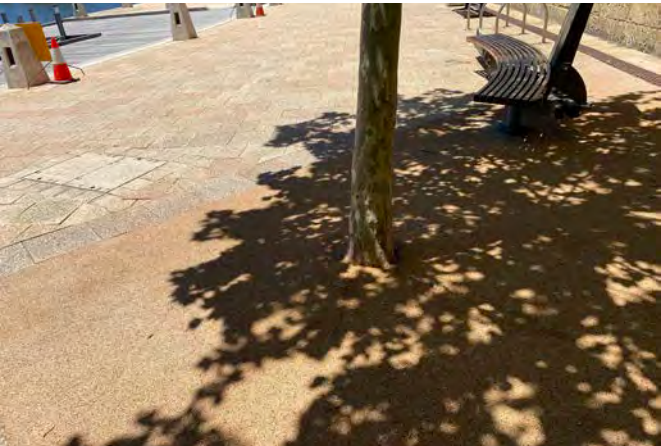
Existing trees lifting paving. Rubber softfall has been used as a solution for access

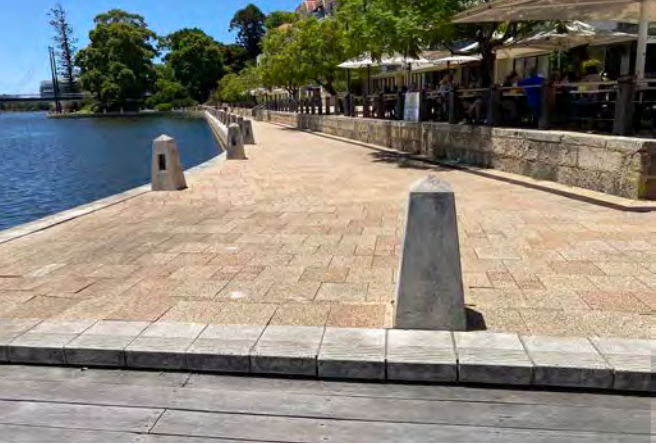
Current configuration of jetty provides a rigid intersection for organic pedestrian movement

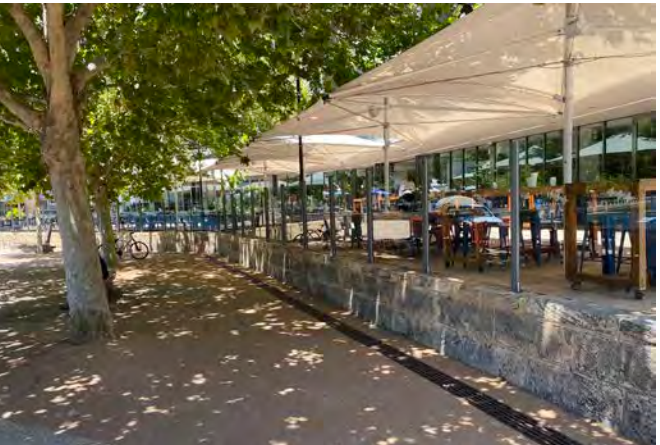
Existing trees lifting paving. Rubber softfall has been used as a temporary solution for access

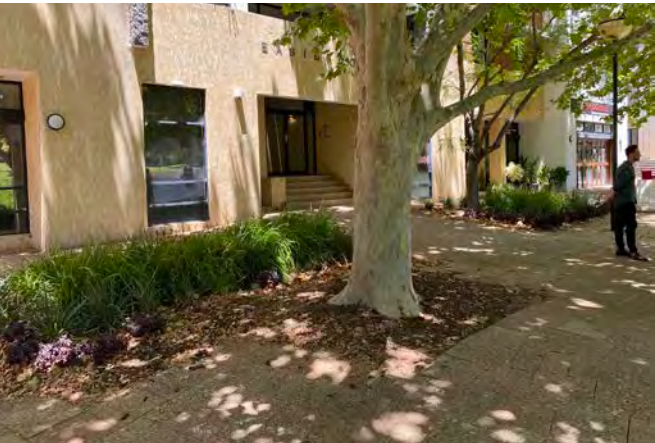
- Tree roots within pedestrian areas are lifting pavement, causing drainage issues & degrading walls
- Access Issues - due to the impact of the existing trees, a majority of the paving has lifted & is currently uneven causing access & tripping risks.
- Condition of walls to lake edge & water features are degraded causing safety issues & impacts overall aesthetics. Rectification works impact overall quality of public realm
- Lack of interface with the lake edge
- Lack of site furniture & aging lighting infrastructure
- Variety & mixed design approaches to level changes to adjacent land uses.

Existing trees lifting paving which creates uneven surfaces for pedestrians

- Review surface treatments around existing trees to increase accessibility, boost tree health & reduce maintenance issues to paving & walls
- Provide additional site furniture around lakes edge to maximise activation
- Review wall treatments around lake edge to provide uniform finish & reduce uneven surfaces within pedestrian access routes
- Opportunity to review the interface between public realm & private tenants to create uniform access & aesthetically pleasing interface
- Opportunity to reduce amount of bike traffic within this walkway & provide pedestrian only traffic to reduce potential clashes

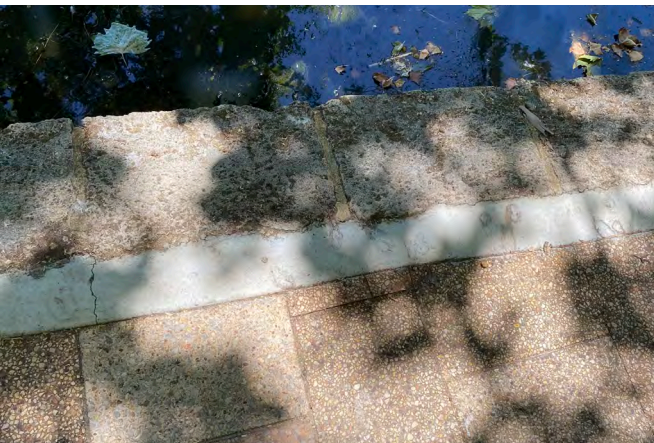
Rectification works to wall edge impacts quality & aesthetic of public realm

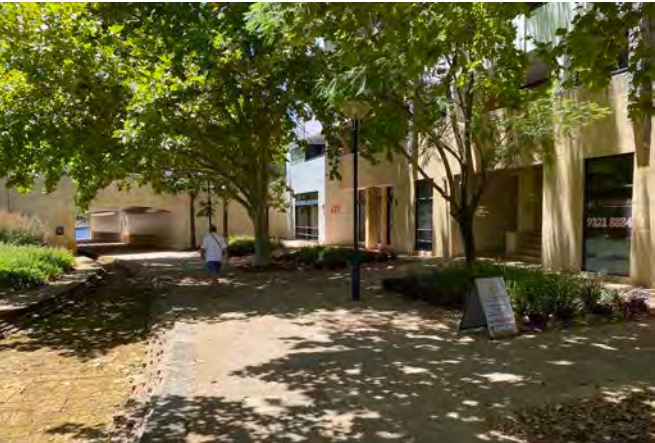
Uneven pedestrian thoroughfares due to existing trees lifting paving

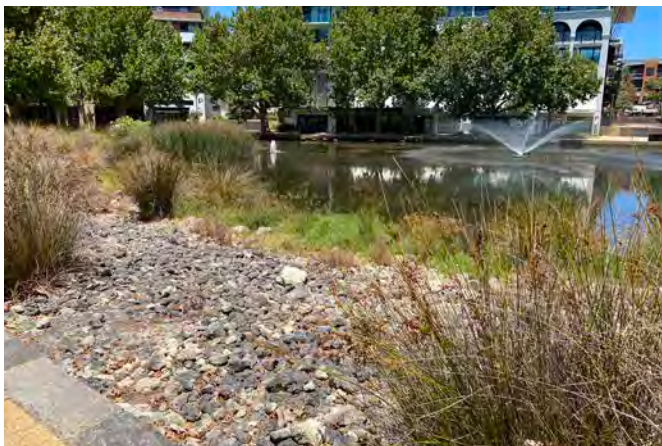
Lack of interaction with the lake. Opportunity to provide boardwalk/decking over lake

- Provide opportunities to interface with lake including boardwalks. Opportunities to provide educational signage & seating opportunities over the lake. Improve outlook over the lake

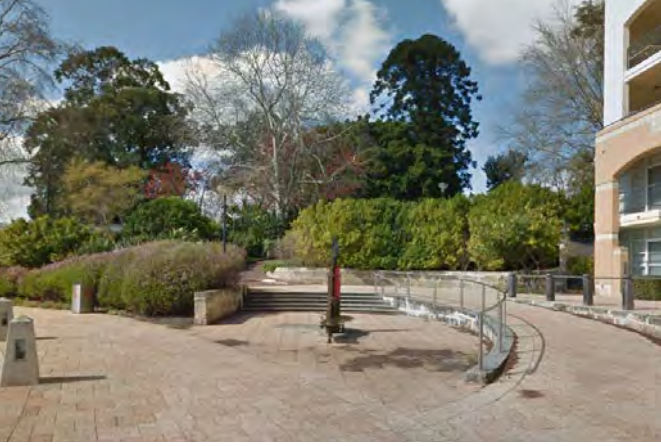
Stairs are located at the base of the bike path creating safety & clashing issues

- Review current design of path alignments & configurations from the Cove to Victoria Gardens to eliminate any clashes between bikes & pedestrians
- Review access & ramp locations within the Cove
- Opportunity to re route the main bike path along the Swan River & Southern edge of the Cove to create a continuous bike route away from major pedestrian links
- General review of levels & pathways from the Cove to Victoria Gardens for better access & CPTED

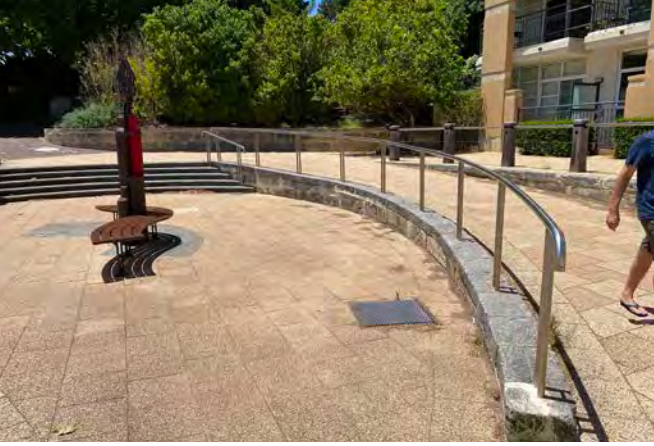
Ramps are disjointed & create pedestrian safety risks with bikes

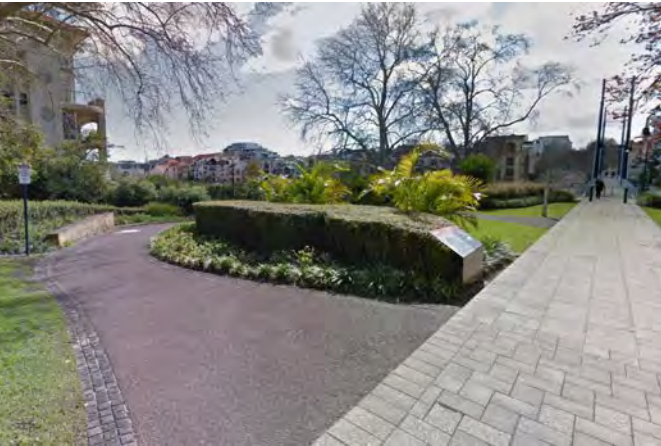
Bike path intersection to bridge connection

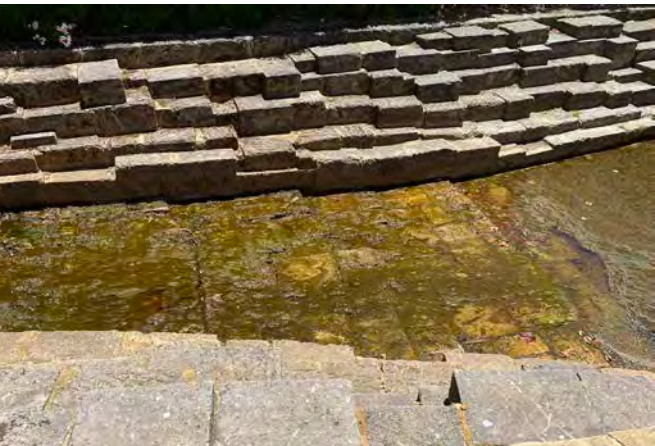
Algae build up to the water feature

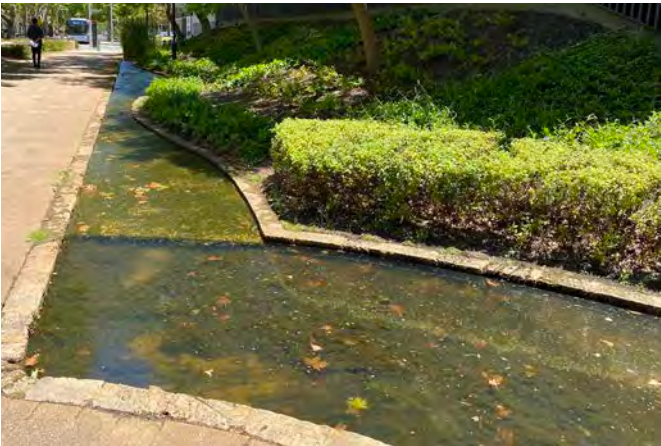
Algae build up to water feature. Lack of water movement in this area

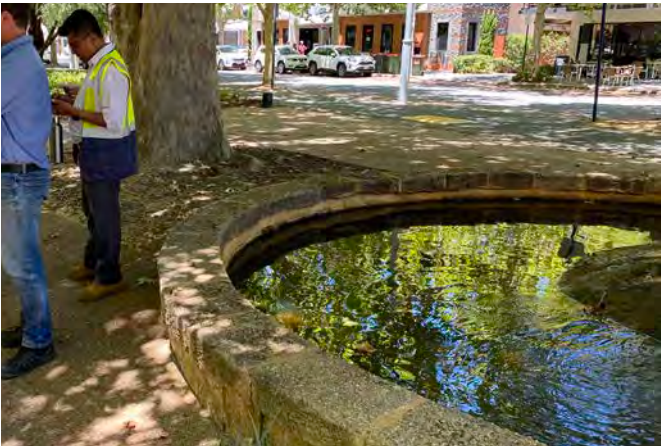
Existing trees lifting paving & impacting water feature walls

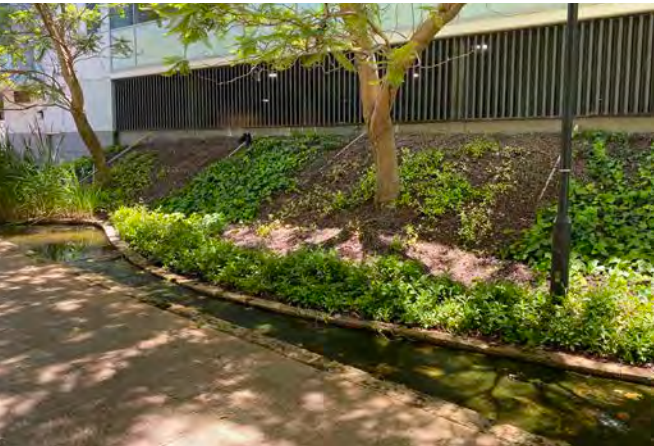
Algae build up to water feature. Lack of water movement in this area & shade from trees

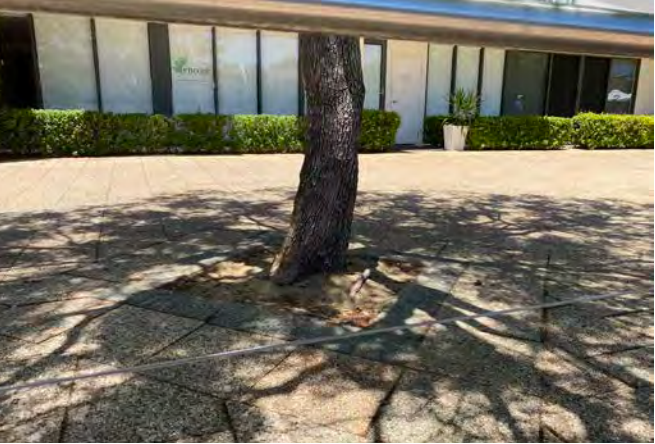
Existing trees lifting paving

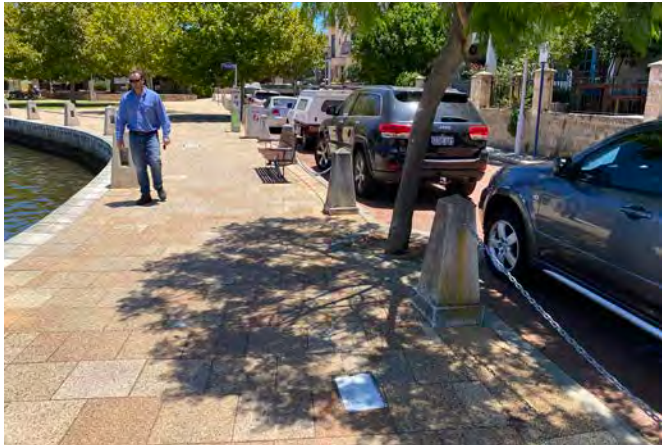
Lack of shade along pedestrian walkway & to site furniture. Opportunity to increase shade.
