# Claisebrook Cove

## IDEAS PLAN

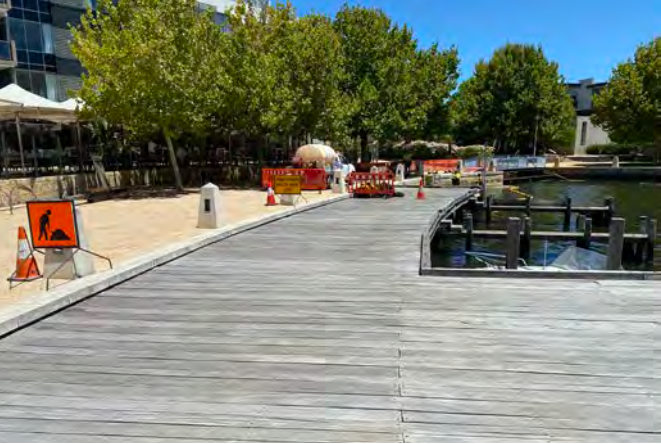
Jetty is underutilised & does not provide enough suitable options for a variety of craft

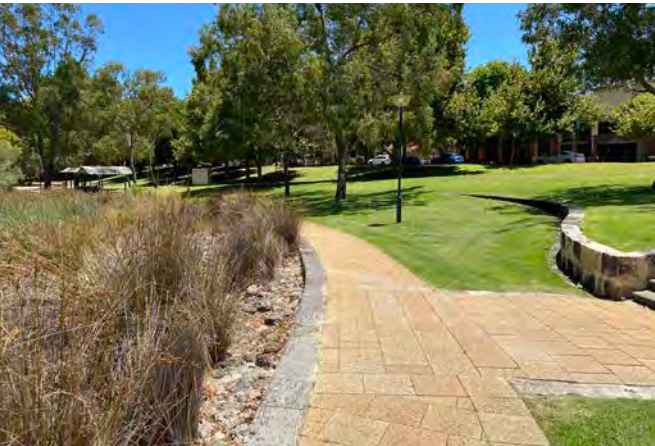
Lack of interaction with the lake. Opportunity to provide educational signage

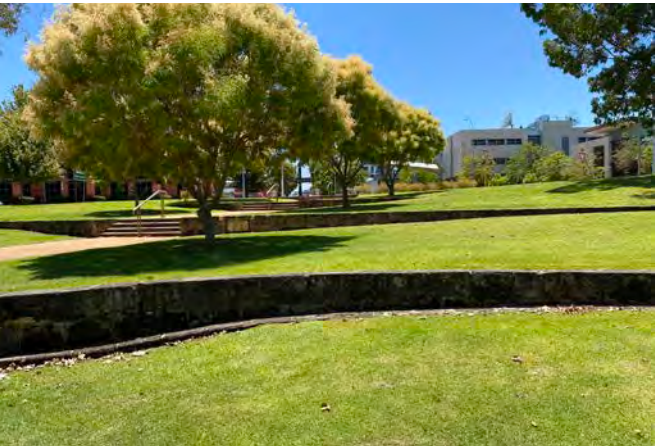
Underutilised spaces within park

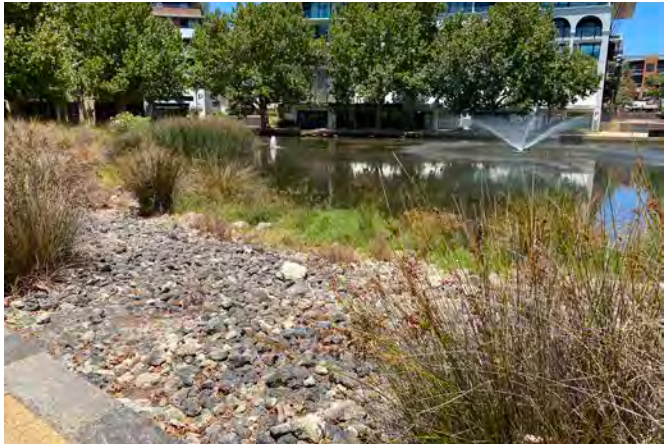
Opportunity to enhance the aesthetic & habitat of the Claisebrook Lake

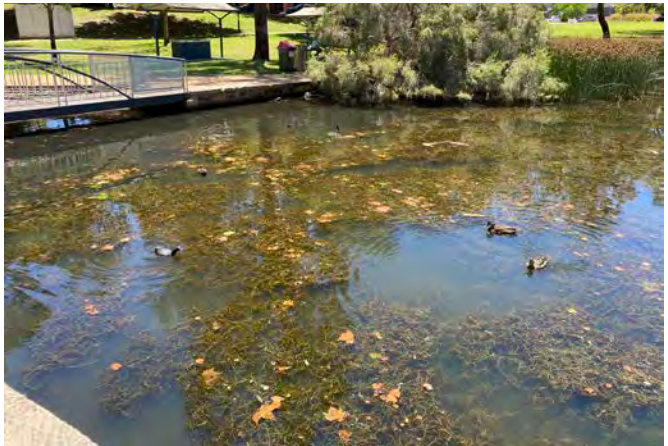
Algae build up at the Claisebrook Lake

- Develop design options for the preferred lake edges. Including potential replacement of lake liner (PVC liner preferred by the City of Perth), conversion of lake to groundwater lake, provide treatment of stormwater prior to collecting at the lake & increasing depth of lake to reduce heating/algae growth. Lake solutions pending Draft Lake Study
- Review wall treatments around lake edge to provide uniform finish & reduce uneven surfaces within pedestrian access routes
- Review current irrigation & pump configuration to the lake to provide better functionality
- Opportunity to increase capacity of the lake to irrigate additional landscaped areas within the City of Perth (Lake currently irrigates 88,091m2)

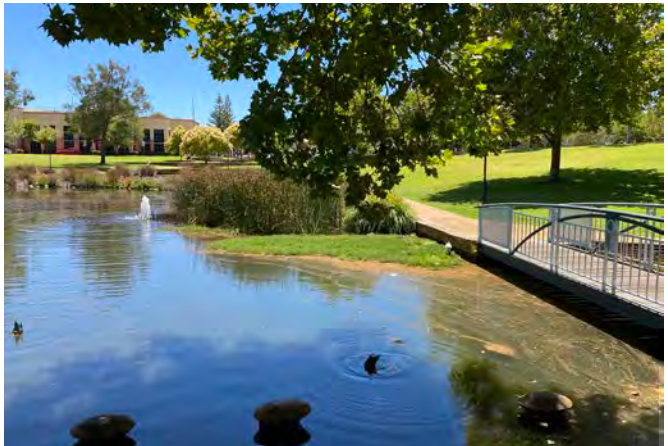
Algae build up at the Claisebrook Lake

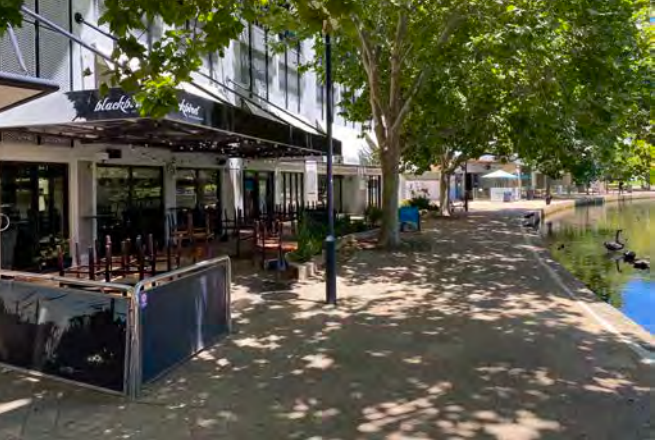
Underutilised lake edge & lack of seating opportunities to take advantage of shade

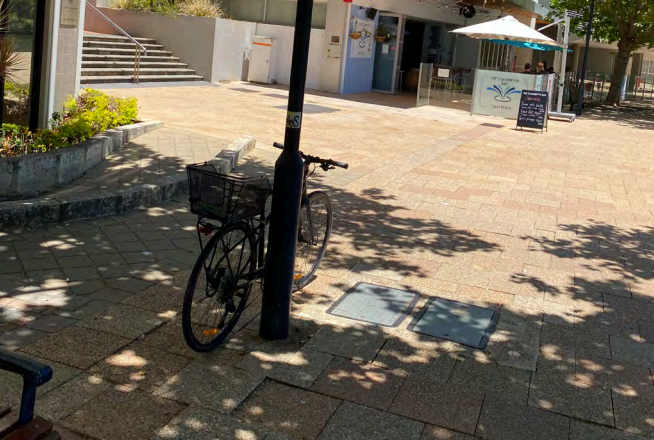
Lack of street furniture around the lake

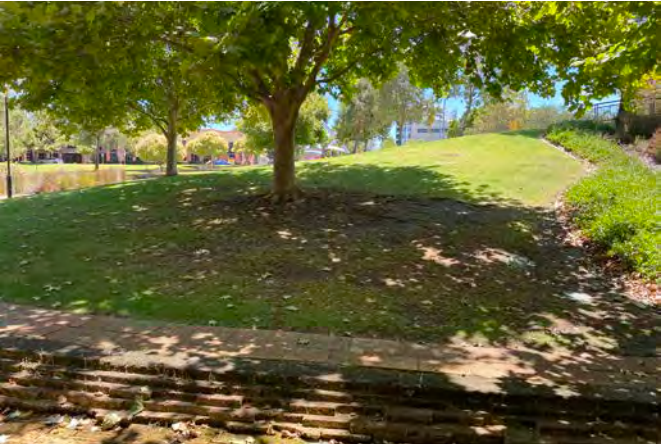
Shade of existing trees impacting growth of understorey & providing underutilised spaces

- Utilise the existing shade to park by providing a variety of seating options. Review surface treatment to this area given turf has failed to increase usability & reduce maintenance

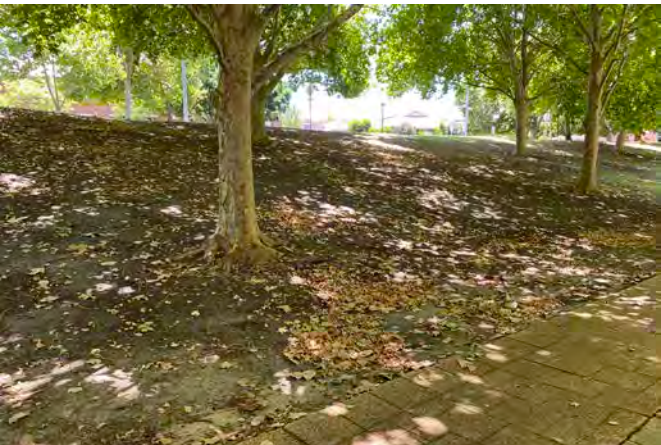
Shade of existing trees impacting growth of understorey & providing underutilised spaces

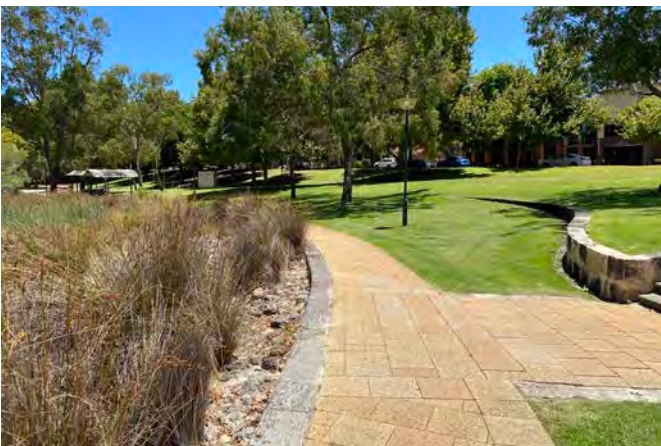
Lack of interaction with the lake. Opportunity to provide educational signage

- Provide opportunities to interface with lake including boardwalks. Opportunities to provide educational signage & seating opportunities over the lake. Improve outlook over the lake

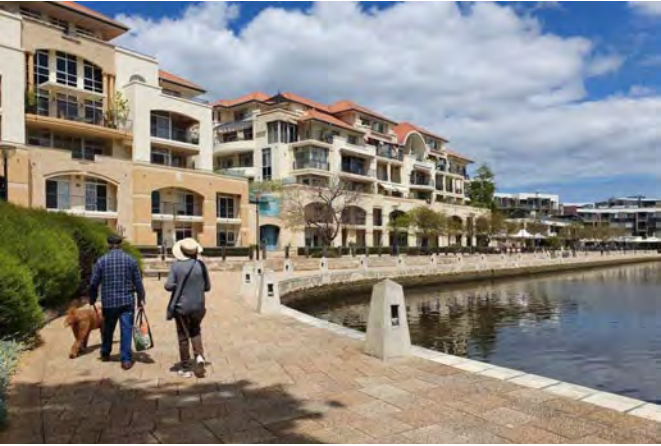
Blind spots to interface with bike path creating safety risks between bikes & pedestrians

- Review current design of path alignments & configurations from the Cove to Victoria Gardens to eliminate any clashes between bikes & pedestrians
- Review access & ramp locations within the Cove
- Opportunity to re route the main bike path along the Swan River & Southern edge of the Cove to create a continuous bike route away from major pedestrian links
- General review of levels & pathways from the Cove to Victoria Gardens for better access & CPTED

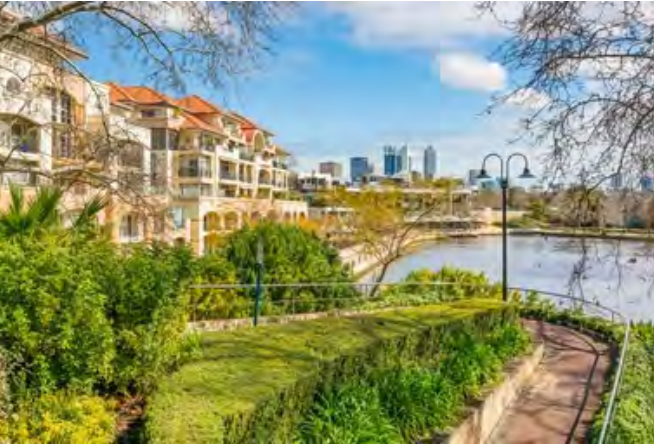
Ramps within Victoria Gardens interface include tight corners & blind spots

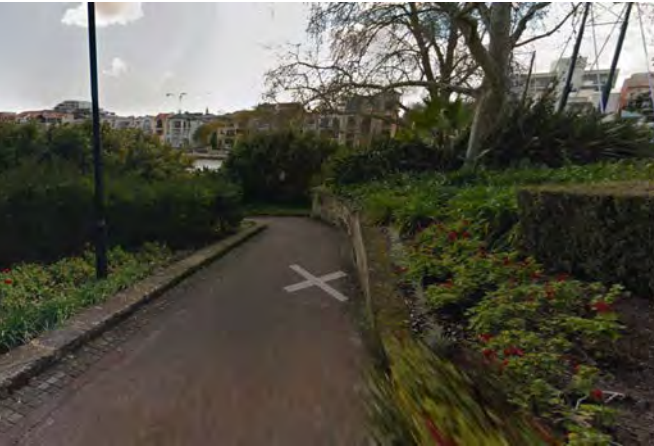
Blind spots to bike path due to tight turns & established gardens

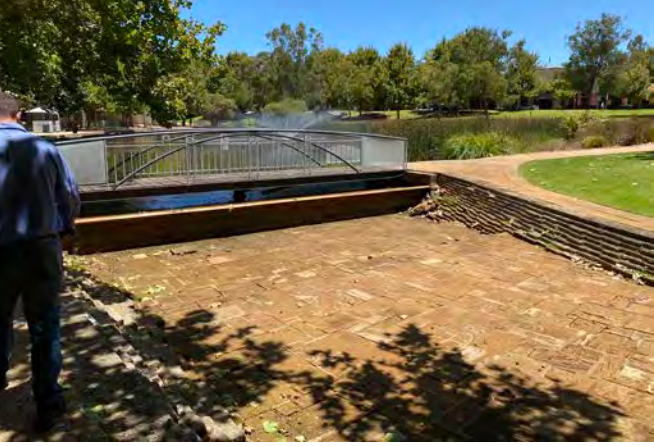
Underutilised water feature when not in use at Claisebrook Lake

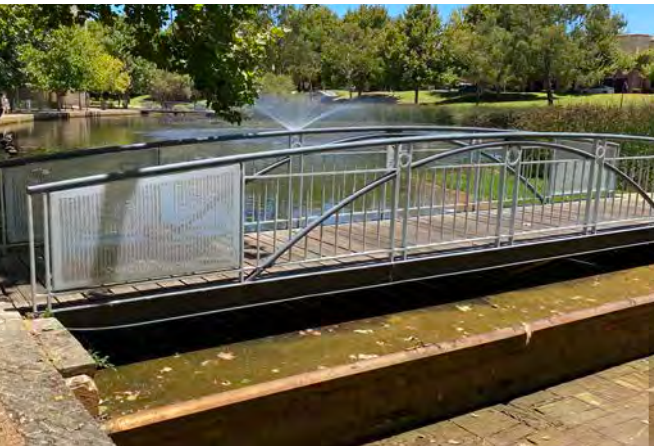
Dated infrastructure & detailing with opportunity to modernise

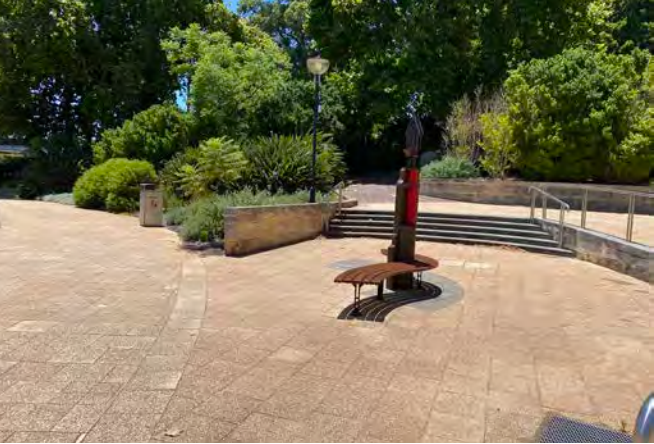
Level changes within public realm provides clashes with pedestrian movement

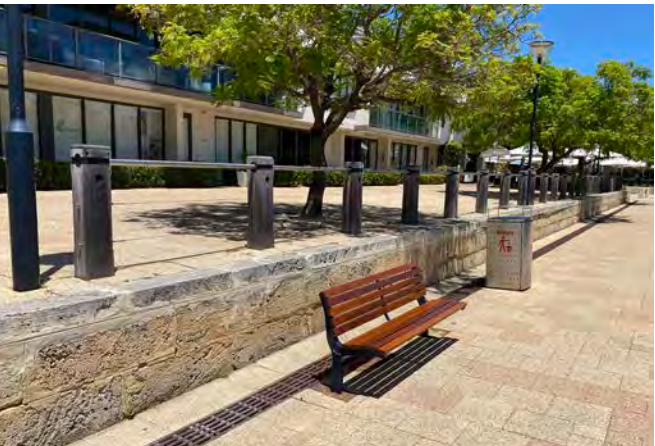
Lack of shade within public realm

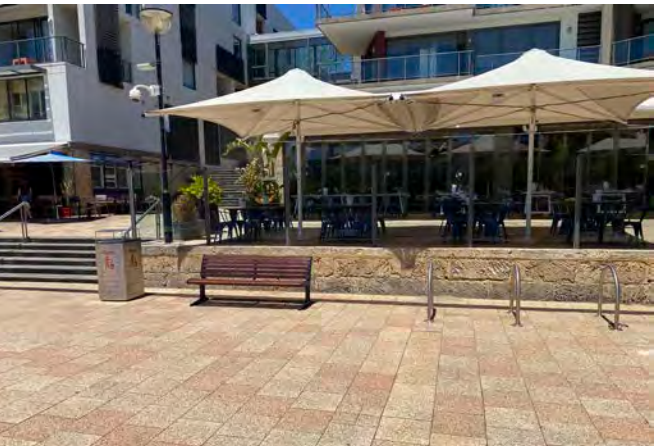
Lack of shade within public realm

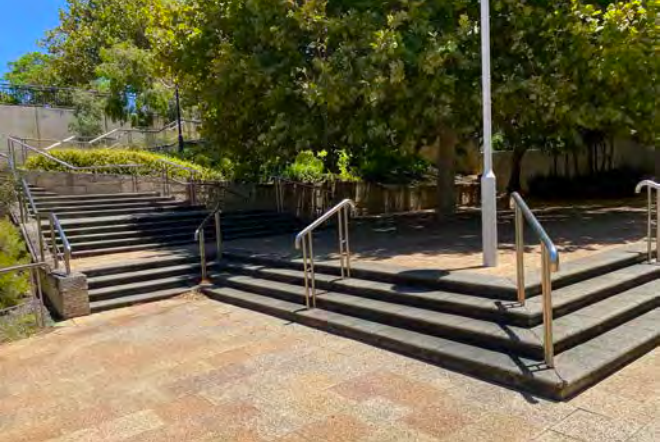
Awkward areas for access. Underutilised spaces throughout project.

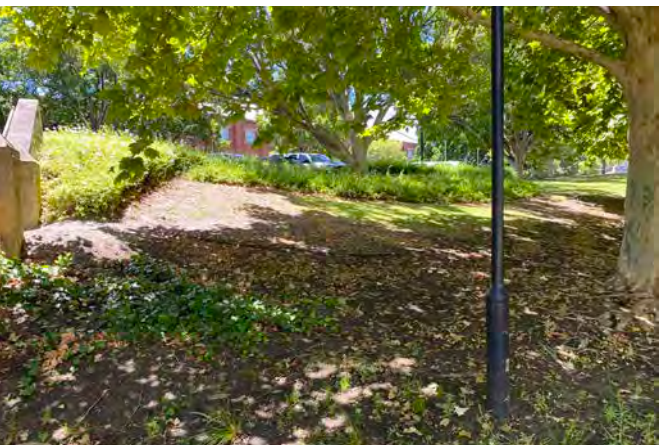
Shade of existing trees impacting growth of understorey & providing underutilised spaces

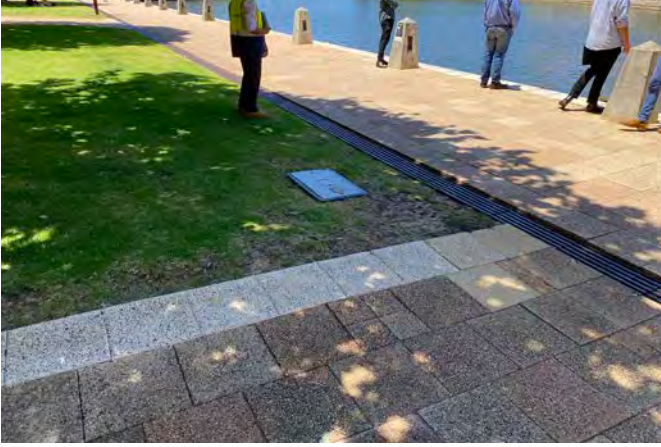
Shade of existing trees impacting growth of understorey & providing underutilised spaces
